Celina Fire Marshal's Office Memorandum

Top Reasons Sprinkler System Installations Fail Inspection

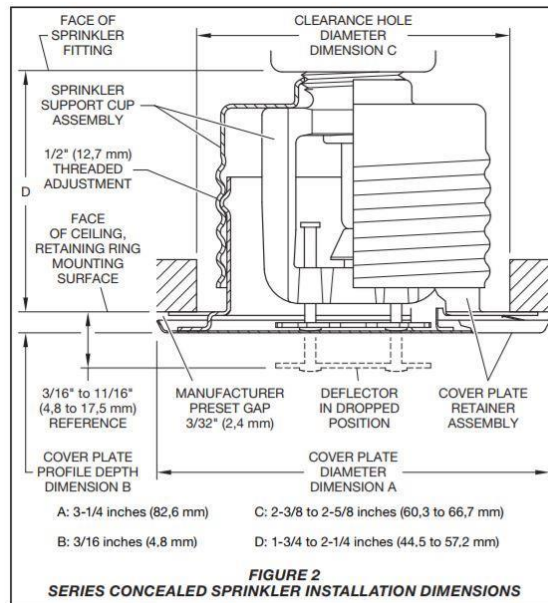
1. Failing to comply with the manufacturer's instructions for sprinkler head installation practices NFPA 13-6.2.7

Sprinkler head installations remain by far the number one reason these installations fail the acceptance inspection. Every manufacturer has installation tolerance's that are often overlooked. This is also the number one contractor contested enforcement violation.

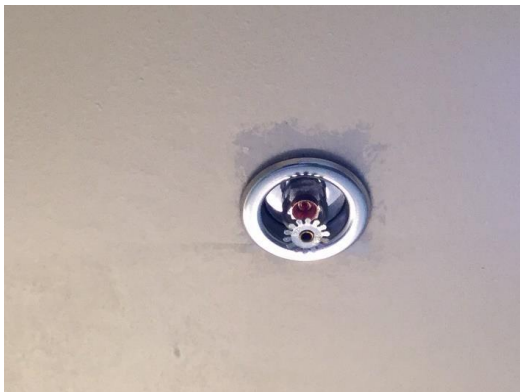
Semi-recessed head with less than 1/2" clearance
Below ceiling surface

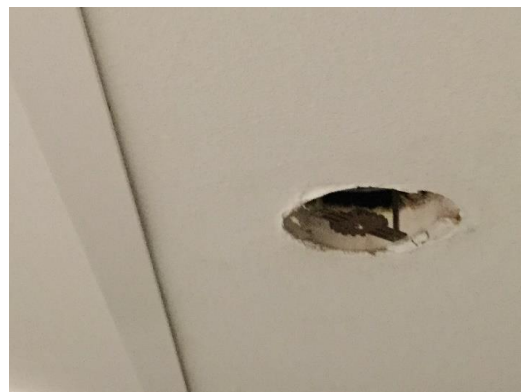
Concealed head with no clearance below
the ceiling surface

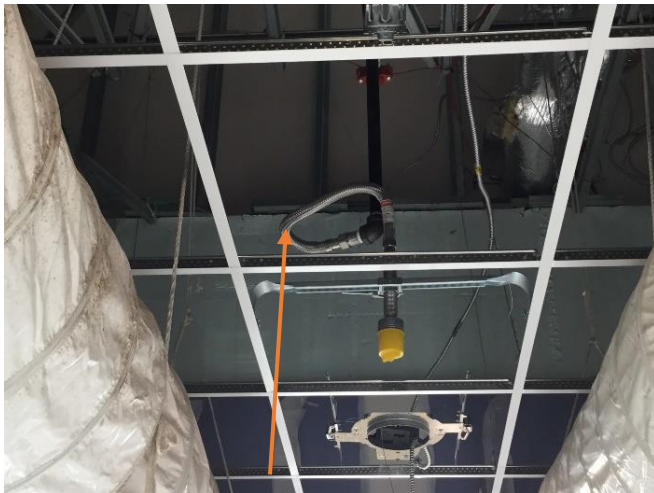
Failing to maintain the 4" minimum radius & number of bends allowed for 2' hose in violation of the U. L. Listing.

2. Failing to comply with the manufactures instructions for Flexible Sprinkler Drops [NFPA 13-9.2.1.3.3.1](#)

* UL: 4" minimum bend radius, where C=120

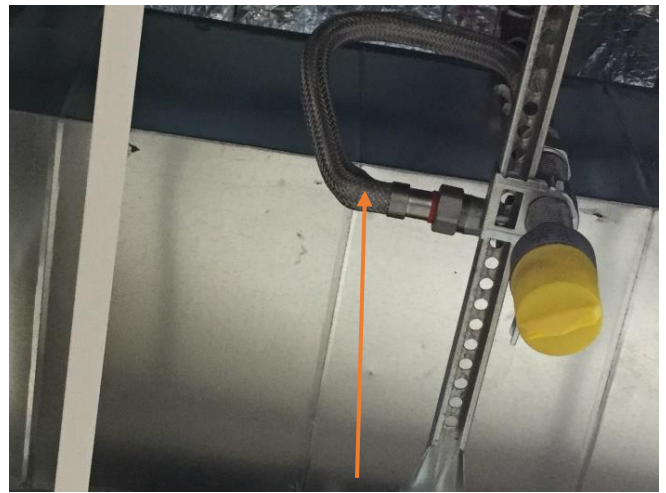
Crimped the hose during installation to achieve center tile.

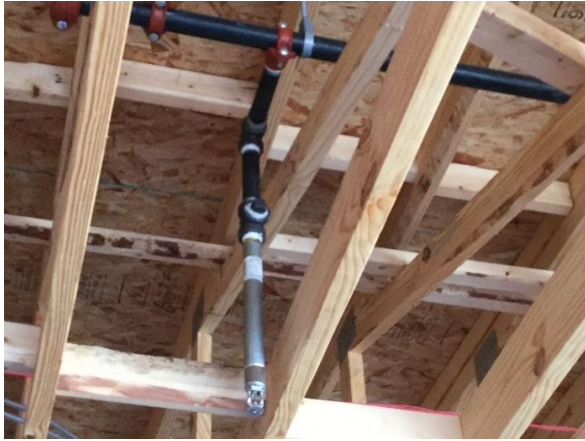
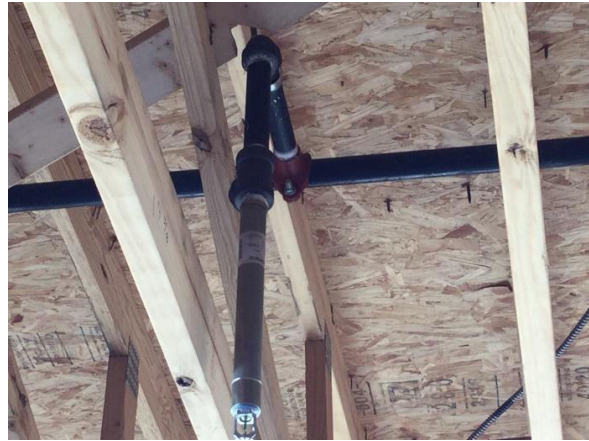
3. Failing to comply with the proper installation of dry pendent heads [NFPA 13-8.4.9.1](#). This environment was a non-climate controlled, non-insulated concealed space.

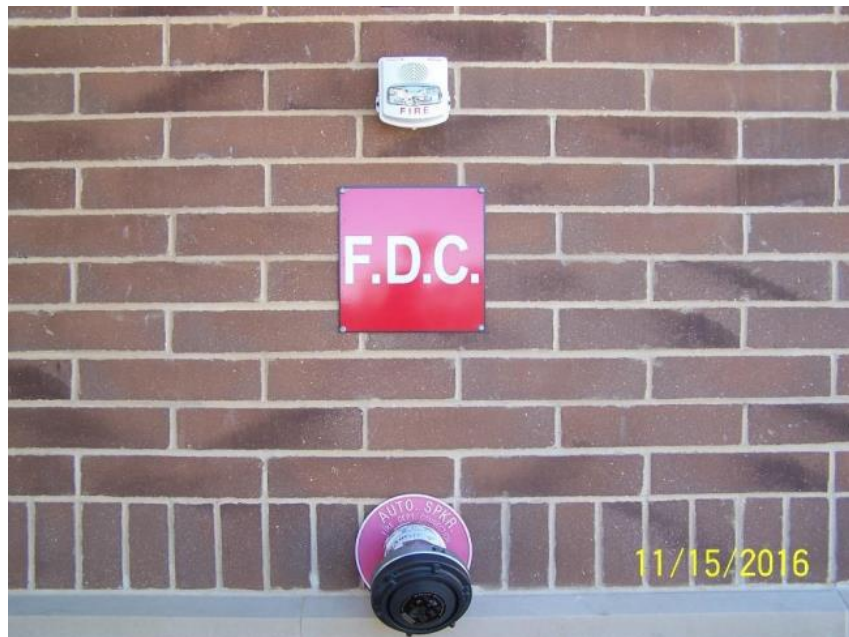
4. Fire Department Connection shall be a 5 inch (5") Storz connection with a 30 degree downward turn, and locking cap. One Storz key shall be furnished to the Fire Department for new installations
